RM A7D28 *Douglas**C-74/1*~~LANGLEY SUB-LIBRARY~~**NACA****RESEARCH MEMORANDUM**

AERODYNAMIC CHARACTERISTICS OF A PORTION OF THE

HORIZONTAL TAIL FROM A DOUGLAS C-74 AIRPLANE

WITH FABRIC-COVERED ELEVATORS

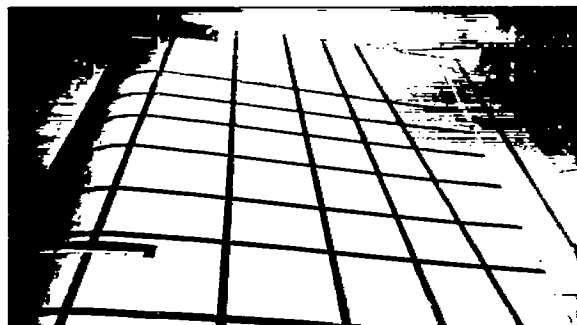
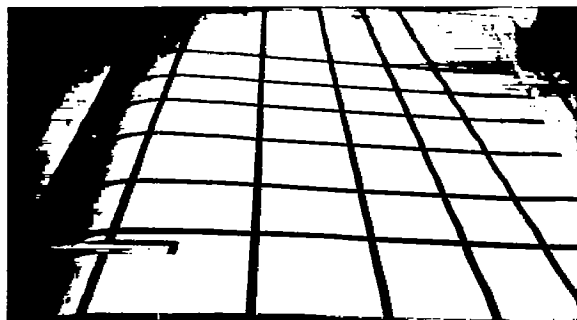
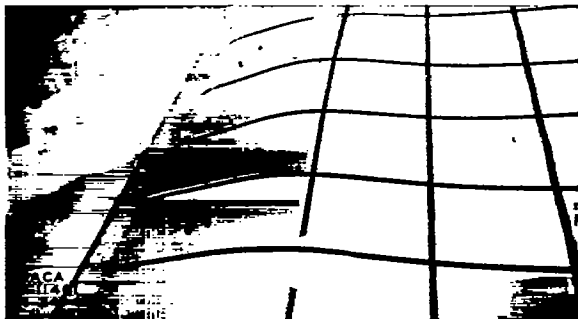
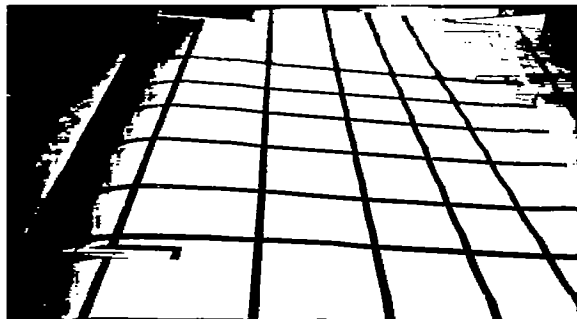
The fourth elevator condition was identical with the first, prior to testing, in representing the part directly off the airplane. However, the fabric on this elevator did not tear loose from the ribs and the bulging and sag were considerably less than that prevailing during tests of the first condition. (See fig. 5.) This fourth condition will be referred to as the "original condition." Control-tab characteristics were measured during this fourth set of tests.

Figure 5.- Photographs showing differences in bulging for the upper surfaces of two similar elevators tested in the Ames 16-foot high-speed wind tunnel.

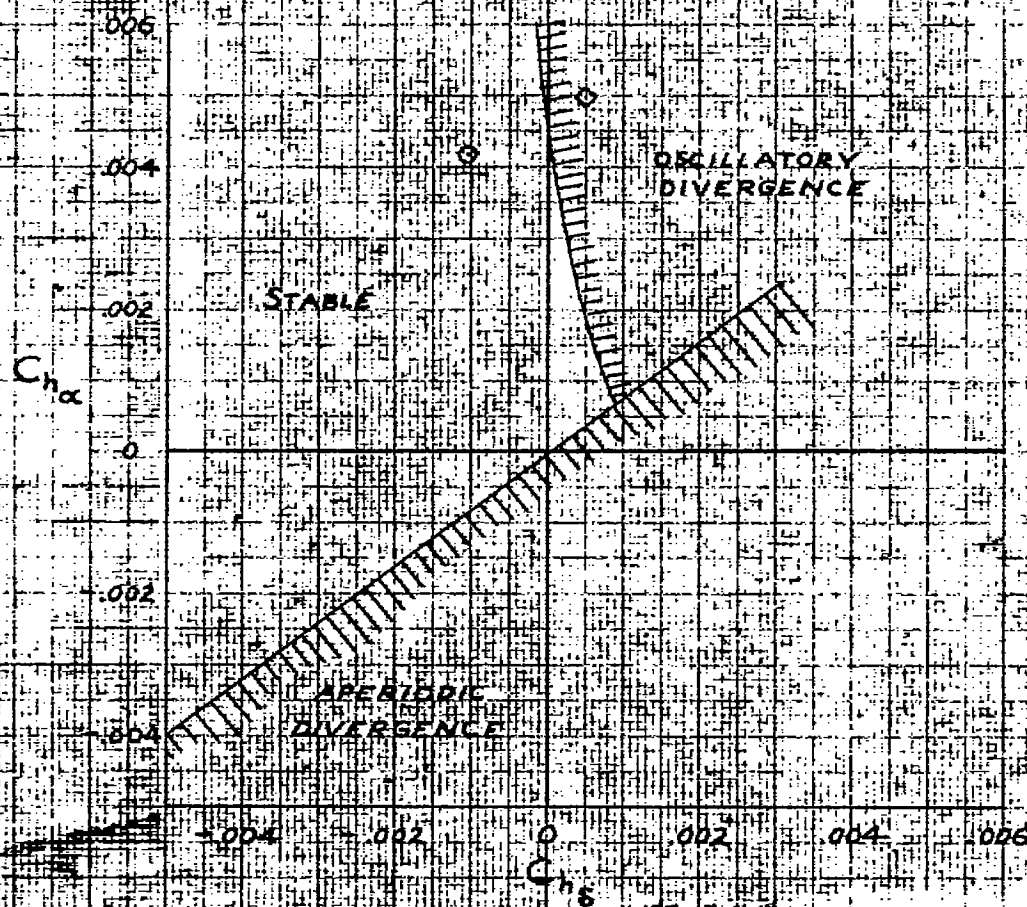
Figure 22 presents the results of an analysis of the dynamic pitching stability of the C-74 airplane made by the Douglas Aircraft Corporation according to the method of reference 3. The flight conditions for which the critical boundaries have been calculated are approximately those under which the accident occurred to the airplane. The experimental data included in the figure are for the fabric-fastened - decreased rib spacing and fabric-fastened conditions. Due to load limits, not enough data were available for the conditions without the fabric fastened to present more test results on the pitching-stability plot. The uncertainty of the tunnel-wall corrections is especially critical in applying this curve as only a slight error in their magnitudes could cause a shift of the experimental points, thereby either denoting stability or instability.

It is shown on figure 22 that either stable or unstable dynamic pitching-moment conditions of the airplane are possible, dependent on the extent to which elevator surface deformation occurs. Unfortunately, it is impossible to reach any definite conclusion from this curve due to the uncertainty of the absolute values of the data. It is evident, however, that for greater dynamic longitudinal stability more negative values of C_{H8} are required. The effect of bulge and sag, in general, was to cause more positive C_{H8} values. The bulging of the fabric over the nose of the elevator changed the nose balance shape to one of greater bluntness. A more blunt nose shape can produce more positive C_{H8} values (reference 1), which would be especially detrimental with a closely balanced elevator of this type. Adverse effects are also attributed, in part, to the beveled trailing-edge section resulting from sag of the fabric between ribs at the aft portion of the elevator. The beveled edge in this case was composed of the trim and control tabs whose surfaces did not deform appreciably under load. Results of flight tests of elevator sections have shown more positive C_{H8} values resulting from beveled trailing edges (reference 4). Wind-tunnel data for beveled trailing-edge elevators having overhanging balance and a blunt nose have shown overbalance at high Mach numbers (reference 5). Elimination of the overbalance, in that case, resulted upon changing to straight-sided elevators. The results obtained from tests of the C-74 elevator show that the only fabric condition in which C_{H8} remained negative with increase in Mach number was that where the surface deformation was held to a minimum by fabric fastening and decreased rib spacing. Fabric fastening and decreased rib spacing may not be the safest solution, however, as upon aging and deterioration of the fabric, it is possible that bulging and sagging may occur with accompanying

FIGURE 22. C-74 AIRPLANE ELEVATOR-FREE LONGITUDINAL STABILITY BOUNDARIES AT CONSTANT SPEED.

After fabric bulge and sag have been reduced to a minimum, still greater longitudinal dynamic stability of the airplane may be obtained by using a sharper nose section or by decreasing the area of the overhanging balance (reference 6). Similar results may also be obtained by extension of the trailing edge, a change which in effect amounts to a decrease in balance. It is recommended that should further tests be conducted for investigation of the effect of these modifications, a smaller model be used so that the absolute values of the aerodynamic coefficients can be obtained more accurately.
